# Manhole Inspection Summary

Manhole # S43CC\_013MH

Insp Date: **1/8/08 9:49 AM**

**Location** Address: **e.eager st**

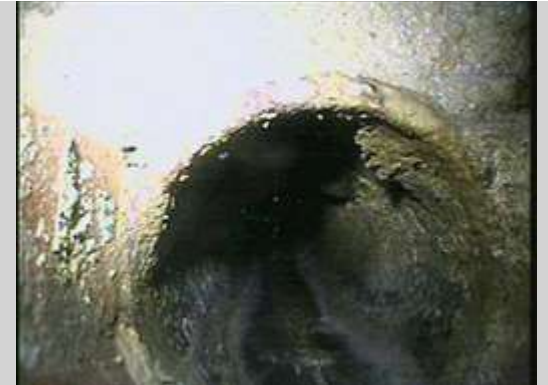
12 O'Clock Outflow

8 in. Circular Gravity Sewer  
Pipe Out @ 12 O'Clock

Invert Depth: **9.10** (ft.) Flow Characteristics: **Slow**

Deposits: ☒ None ☐ Mud ☐ Sludge ☐ Debris ☐ Grease

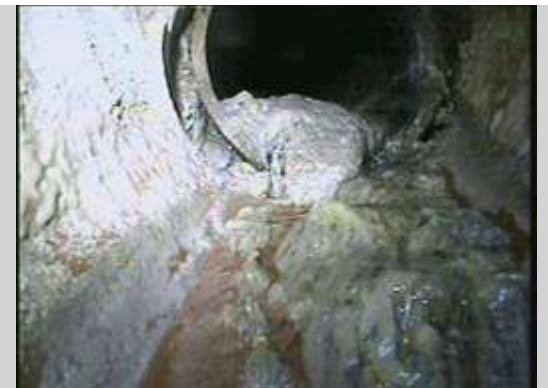
3 O'Clock Inflow

8 in. Circular Gravity Sewer  
Pipe In @ 3 O'Clock

Invert Depth: **9.00** (ft.) Flow Characteristics: **Slow**

Deposits: ☐ None ☐ Mud ☐ Sludge ☒ **Debris** ☐ Grease

Silt Depth: 3 (in.) Deposits Extent: **Medium**

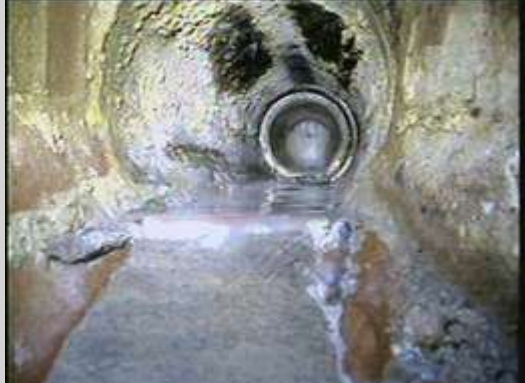
9 O'Clock Inflow

8 in. Circular Gravity Sewer

Pipe In @ 9 O'Clock

Pipe Material: **Clay** ☐ Pipe Lined

Invert Depth: **8.90** (ft.) Flow Characteristics: **Slow**
